وزارة الطيران المدني  
الإدارة المركزية للحوادث

### التقرير الفني

عن واقعة انفصال قلابات الهواء FLAPS عن الجناح الايسر للطائرة  
المسجلة SU-BMK من طراز COMMANDER 114B التابعة للتابعة لأكاديمية  
المصرية لعلوم الطيران خلال اجراء اختبار جوى للطائرة بمطار ٦ اكتوبر

يوم ٢٠١٢/١٢/٢

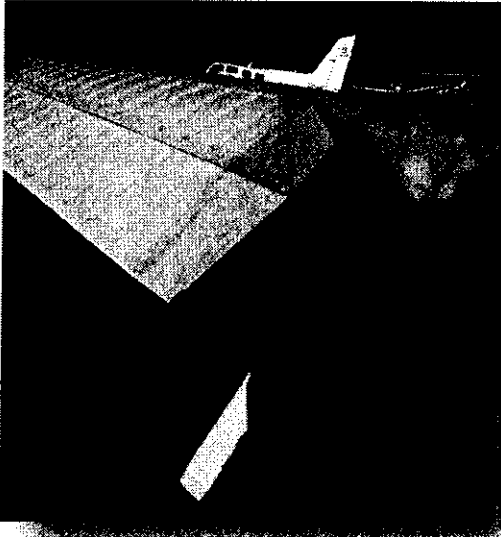
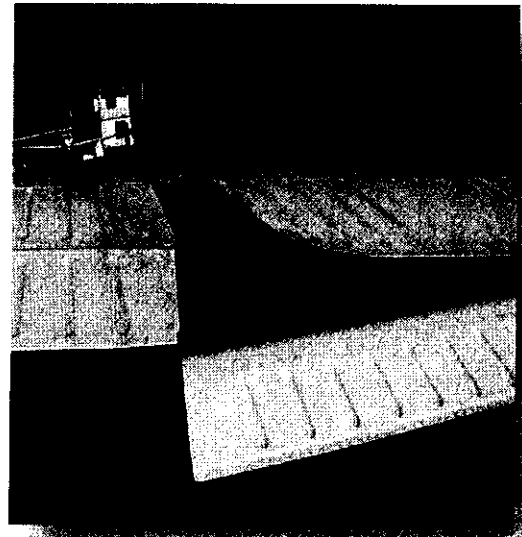
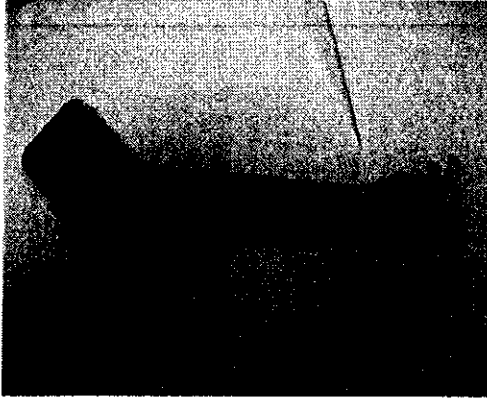
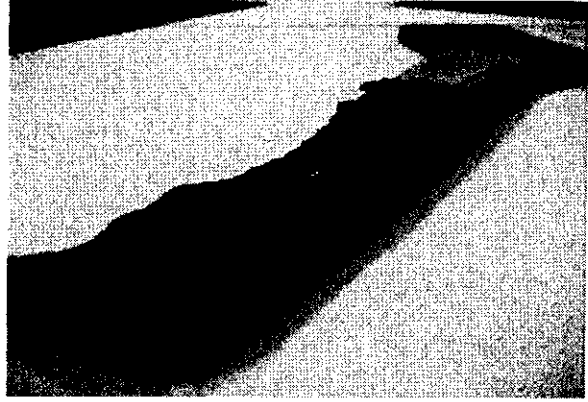
- بعد الواقعة تم الكشف على الطائرة فتلاحظ مايلى :-
- انفصال FLAP الايسر عن الجناح من التثبيت الخارجى .
- انثناء FLAP الايسر فى اتجاه جسم الطائرة واصبح عموديا على الجناح (فى وضع راسى) .
- تاكل الجزء الخاص بتثبيت جسم FLAP بالجناح الايسر .

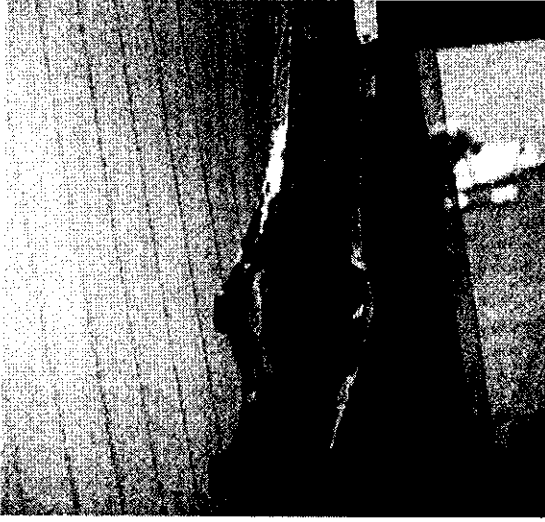
- تم معاينة الطائرة داخل هجر الصيانة بمطار ٦ أكتوبر وقد تلاحظ مايلي:
- انهيار كامل لقلاب الهواء الايسر *LEFT FLAP* ومجرى التثبيت الخاص بـ *TRACK FITTING*

- انفصال القلابة اليسرى عن الجناح نفسة من تثبيتها الخارجى .

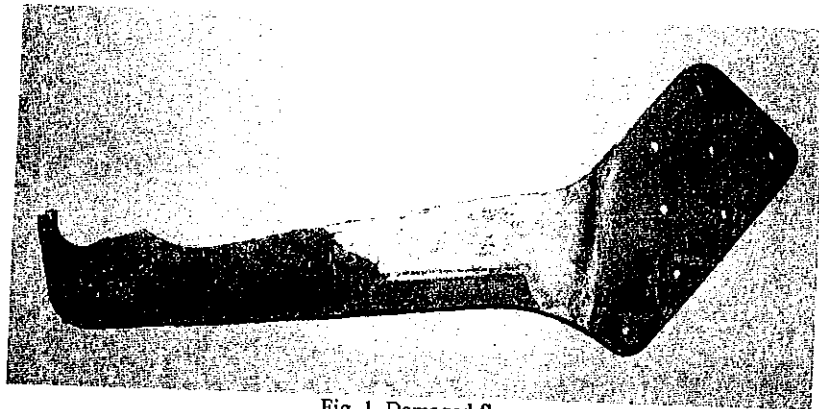
Fig. 1 Damaged flap arm

The left wing flap arm of the aircraft (SU-BMK) model C114B has been failed on December 2, 2012 during a test of the aircraft in the 6<sup>th</sup> of October airport. The damaged flap arm was submitted to CMRDI by the Central directorate of aircraft accident investigation for a possible failure analysis. Fig. 1 shows a photo of the as received damaged flap arm.

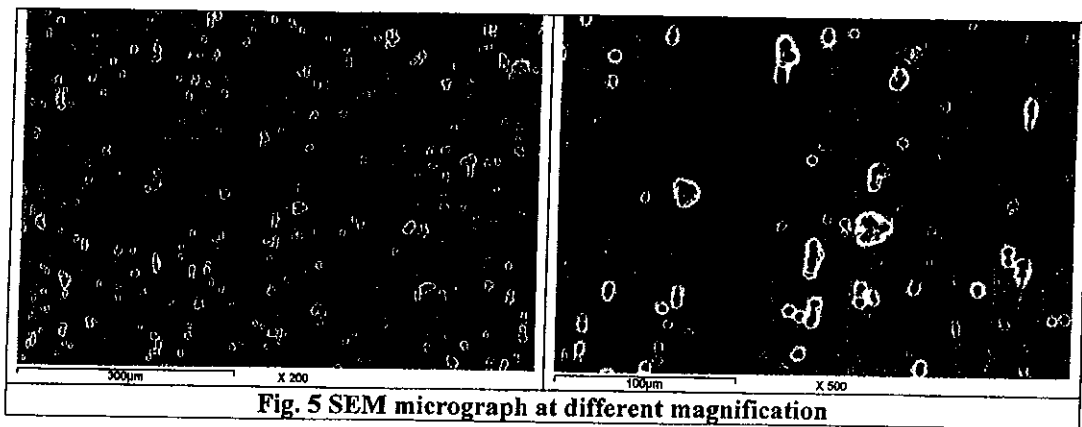
**Fig. 5 SEM micrograph at different magnification**

Scanning Electron microscope (SEM) was used to clarify the quality and distribution of the particulates. Fig. 5 shows particulates shape and distribution at magnifications X200 and X500 respectively. The particulates could be either graphite or alumina particles.

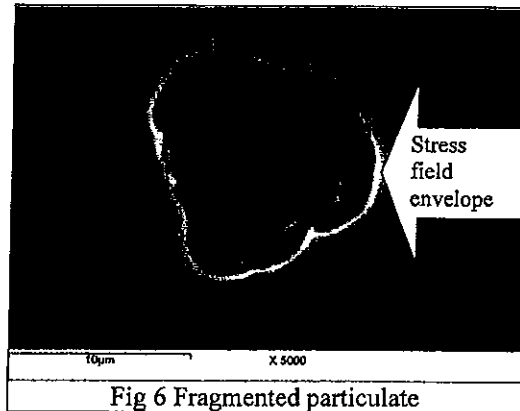
**Fig 6 Fragmented particulate**

Fig. 6 contains a micrograph focuses on one of the particulates at high magnification (X5000). The particulate contains sharp edged corrugated surface resulting during matrix deformation. Sharp edged corrugated surface particulates are frequently alumina rather than graphite. Furthermore, the particulate is surrounded by a thin envelop (white) stress field.

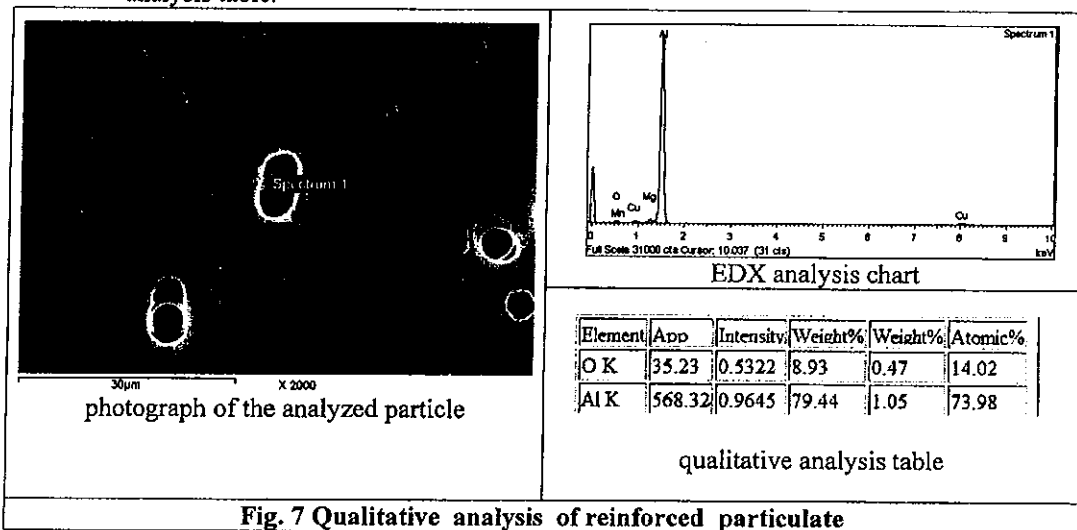
**Fig. 7 Qualitative analysis of reinforced particulate**

A qualitative analysis has been done by the x-ray (EDX) provided by the scanning electron microscope (SEM) on some selective particles. Fig. 7 shows a photograph of the analyzed particle and the EDX analysis chart provided with a qualitative analysis table.

The qualitative analysis emphasizes that the reinforced particulates are mainly Alumina ( $Al_2O_3$ ) particles.

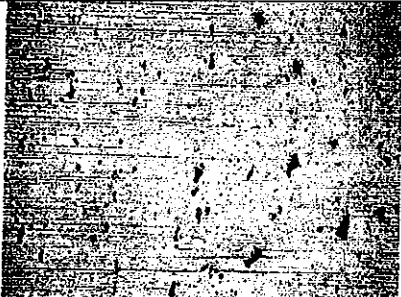
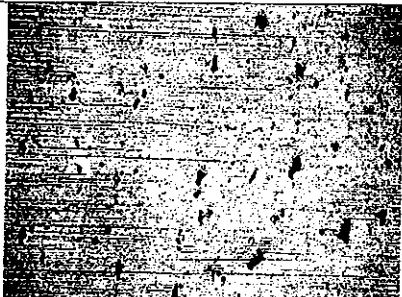
Fig. 8 Original and filtered microstructure of two areas

An identifying microscope was also used to assess the volume fraction of the reinforced particulate. Fig. 8 shows two slices original microstructure and filtered ones. The computer identifies on slice #1 about 6.2% volume fraction particulates with a size 20  $\mu m$ , while in slice #2, the computer identifies about 2.8% volume fraction particulates with a size 27  $\mu m$ . As an average, the metal matrix contains about 4.5% volume fraction  $Al_2O_3$  particulates.
