# Final Report

Concerning  
Airbus A321 aircraft tail strike

At Hurghada Airport

Registration VQ-BOC

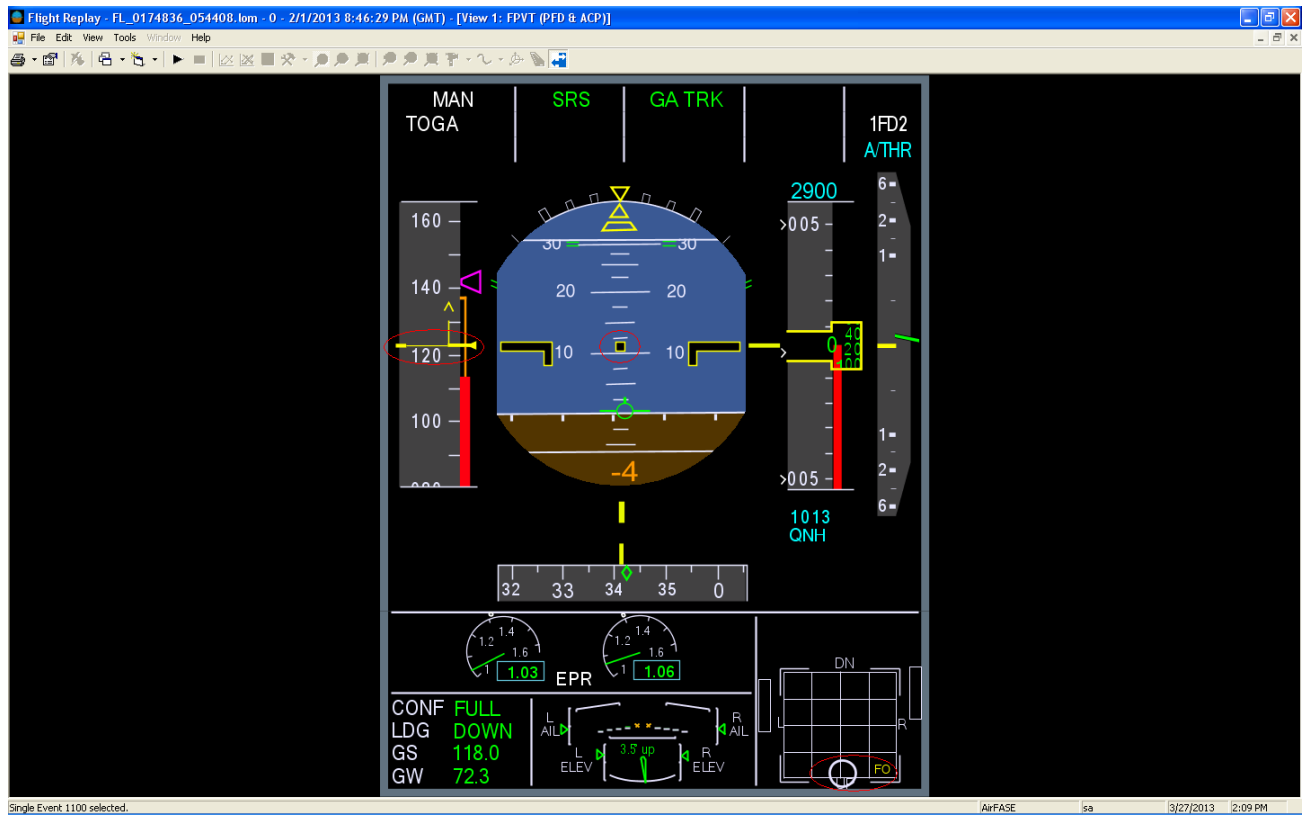
The following PFD drawing is shown for better understanding of the parameters follow up

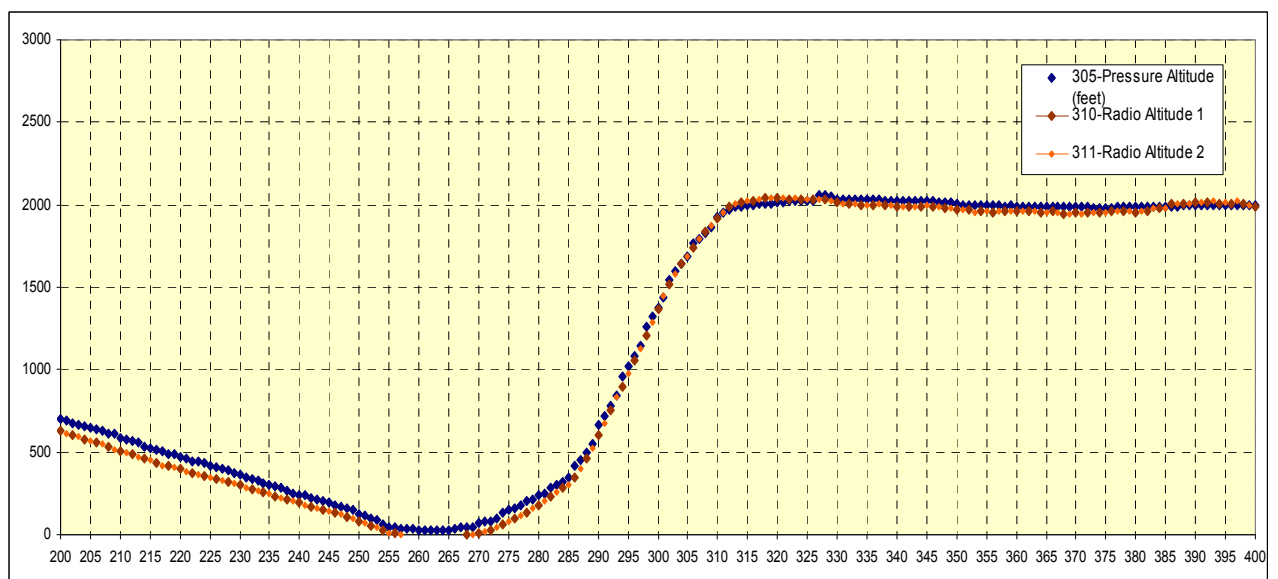
##### 1. Press Altitude, Radio Altitudes

(Most of the plots are made twice. The first set of plots addresses the whole event time, the second set addresses and focus on the incident time)
